Decision Document for Soil at the Base Collection Pond, Site 5

144TH FIGHTER WING CALIFORNIA AIR NATIONAL GUARD FRESNO AIR TERMINAL, FRESNO, CALIFORNIA

Draft Decision Document for Soil at the Base Collection Pond, Site 5 144th Fighter Wing, California Air National Guard Fresno Air Terminal Fresno, California

January 1996

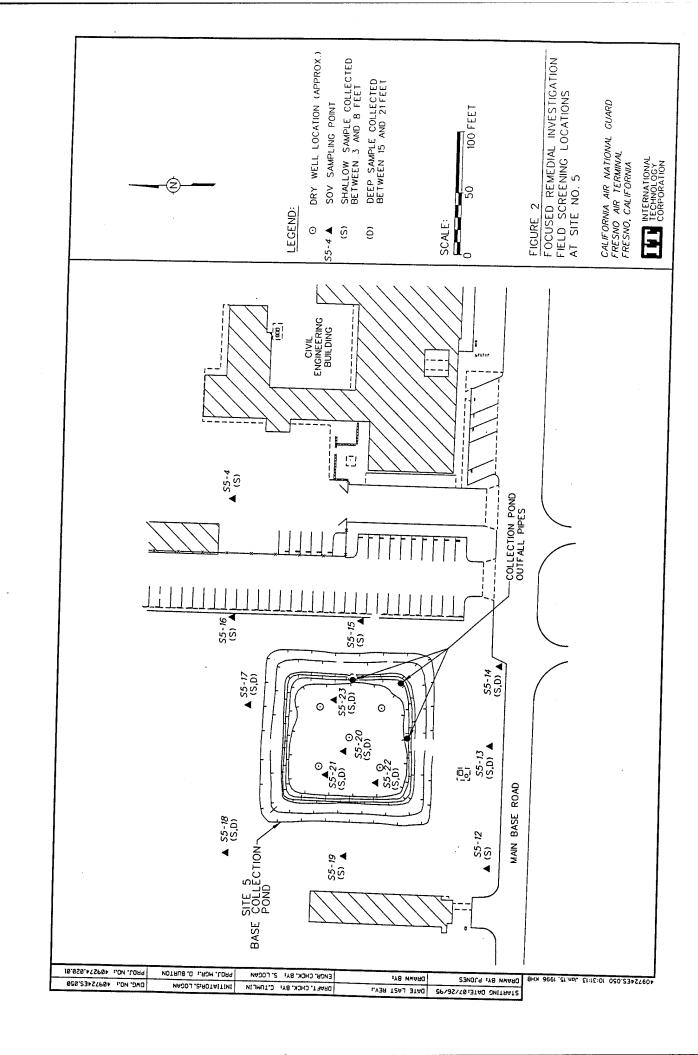
SOV samples collected above the hardpan ranged in depth from 3 to 8 feet bgs; SOV samples from below the hardpan were collected from depths of 15 to 21 feet bgs. Samples were collected around the BCP, within Site 5, west, southwest, and northwest of the petroleum, oil, and lubricant facility, and in the north perimeter field. SOV sampling locations in and around the BCP, with their relative depth ranges, are shown in Figure 2.

No positive detections were reported for any shallow or deep SOV samples collected across the western portion of the Base or within the BCP.

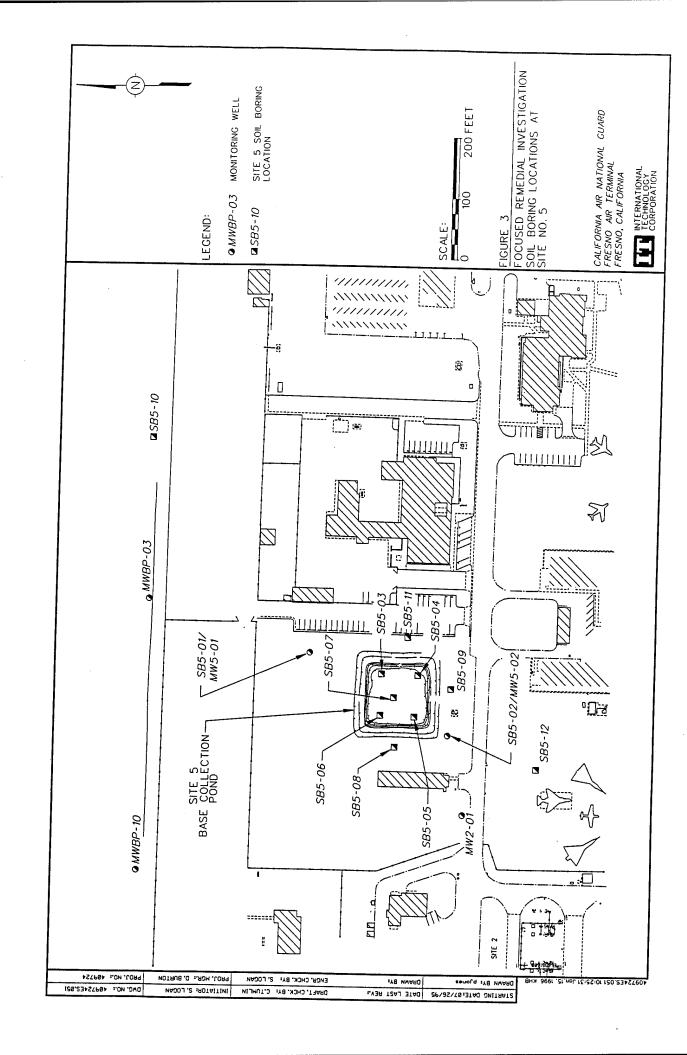
Twelve soil borings were drilled and sampled to the water table during the focused RI activities, at the locations shown in Figure 3. Five borings (SB5-03 through SB5-07) were located in the bottom of the BCP and extended to a depth of 65 feet below ground surface (bgs) where groundwater was encountered. Five other borings (SB5-01, SB5-02, SB5-08, SB5-09, and SB5-11) were located along the top edge of the BCP and sampled to a total

A total of 64 soil screening samples were collected from the 5 borings located at the bottom of the BCP (SB5-03 through SB5-07). Of the VOCs analyzed, PCE was detected in 18 samples, TCE was detected in 12 samples, and dichloroethene (various isomers) was detected in 2 samples.

PCE was detected at concentrations ranging from 51 to 640 μg/kg, with an average detection of approximately 190 μg/kg. TCE was detected at concentrations ranging from 51 to 410 μg/kg, with an average detection of approximately 170 μg/kg. Detections of PCE and TCE were sporadically distributed throughout the soil profile. At no specific depth interval were PCE or TCE always detected, nor was a continuous column (from the bottom of the BCP to the water table) of PCE or TCE present. Detections closer to ground surface were generally bounded above and below by nondetects. Detections within 10 to 15 feet of the water table were generally more continuous. TCE was only measured where PCE was also measured, suggesting that TCE was possibly present as a result of degraded PCE.
